WSTF-IR-1129-001-08
December 10, 2008

Investigation, Analysis, and Testing of Self-contained Oxygen Generators

**Lyndon B. Johnson Space Center
White Sands Test Facility
PO Box 20
Las Cruces, NM 88004
(575) 524-5011**

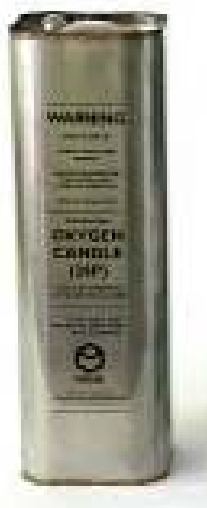
Figure 1
SCOG26 (Photo Copyright Molecular Products, Ltd., U.K.)

A SCOG is sometimes referred to as an oxygen candle whose purpose is to provide an emergency supply of breathable oxygen from the combustion of a chlorate oxidizer and suitable fuel. The particular SCOG of this investigation is a SCOG26, developed and marketed by Molecular Products, Ltd., Thaxted, Essex, England. The SCOG26 oxygen candle is shown in Figure 1.

The SCOG26 name is partially derived from the oxygen generation capability of the candle. The “26” refers to the 2600 L of oxygen gas at standard temperature and pressure (STP) that the candle will normally produce over the course of operation. The standard burn time for this type of device can vary depending on environmental conditions, but is typically on the order of 45 to 60 min. This reaction rate produces a maximum gas generation rate of roughly 1 L/s (0.0353 scf/s) under normal operating conditions.

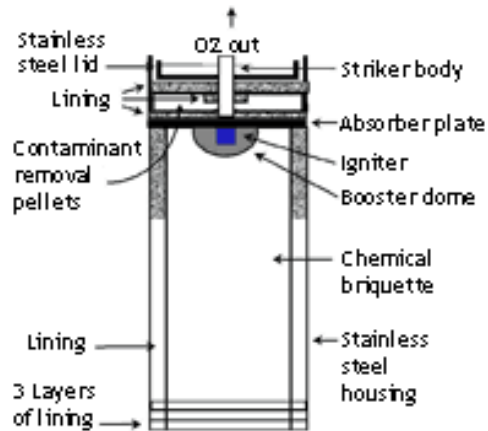
Figure 2
SCOG Cross-section Schematic (Molecular Products, Ltd.)

A generic cross-section view of the SCOG26 is shown in Figure 2. The bulk of the system is comprised of candle brick material. The brick material is ignited via an igniter cartridge (typically a .410 caliber cartridge containing black powder) inserted into the top of the SCOG26 and secured in place by a screw-on striker pin assembly. The striker is operated manually and struck using the palm of the hand to drive a pin into the igniter primer. The igniter cartridge fires hot gases down a tube that has direct access to the top of the oxygen candle. The top region contains a greater percentage of iron than the bulk candle and generates more heat to ignite the next section. This ignites an iron enriched “dome” region containing ~ 30 percent iron and 70 percent chlorate. A thin layer of ~ 15 percent iron-enriched material then burns across the top of the main brick material to promote uniform combustion along the top surface area of the candle. This ignition train provides the initial thermal input, allowing the reaction to proceed into the lower iron content region (less than 8 percent) for the remainder of combustion and maintain the required temperature in excess of the decomposition temperature of the sodium chlorate (300 °C, 572 °F).

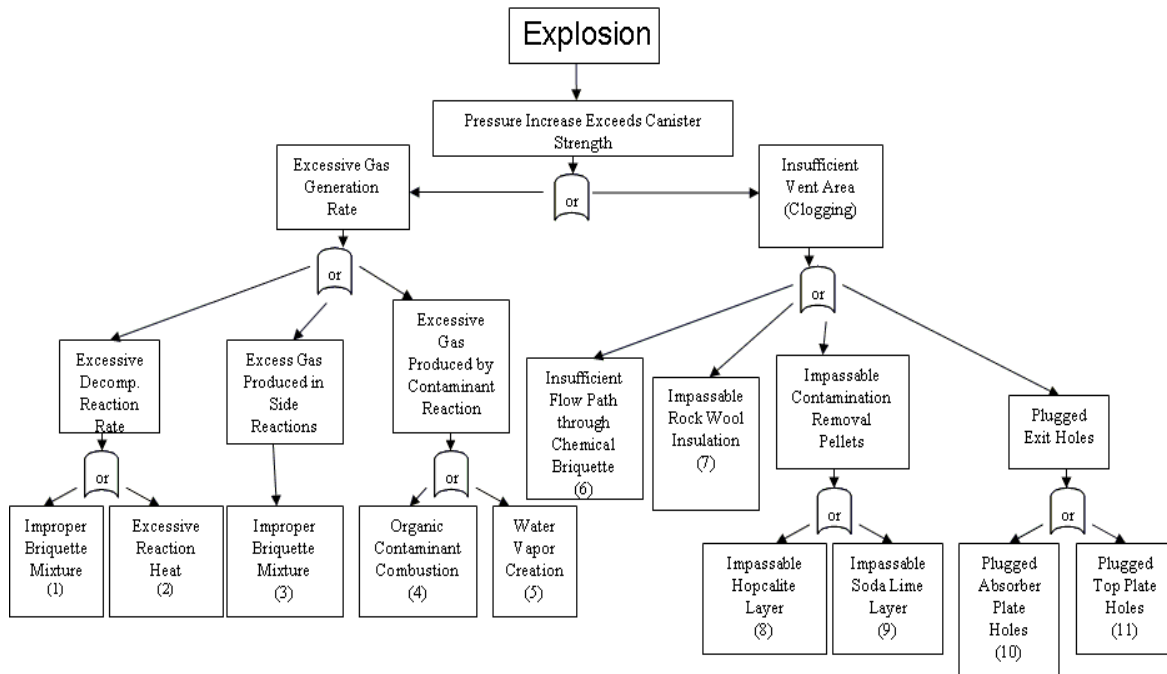
Figure 3
Fault Tree

Three different analytical techniques were used to analyze the accident, document lines of reasoning, and guide the experimental process. Each of the three techniques serves a useful purpose. None of the three techniques alone can fully capture the analysis. The three analytical techniques are: fault tree analysis, root cause analysis, and failure modes and effects analysis (FMEA).

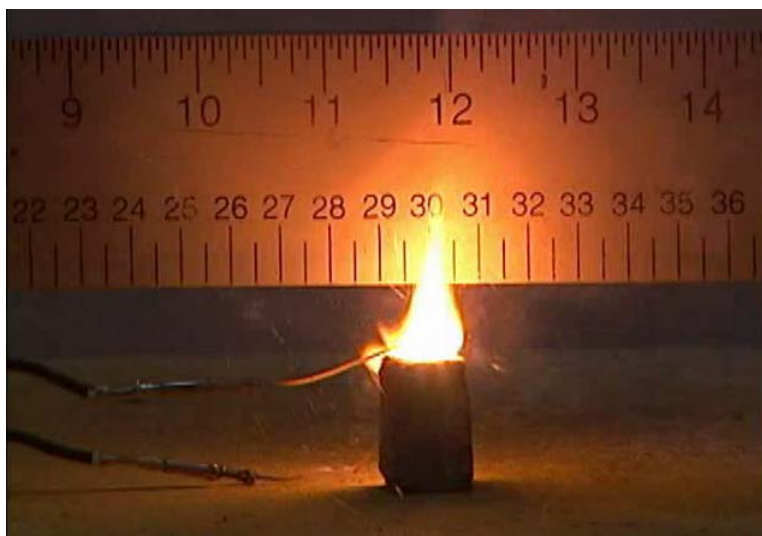
Figure 5
Brick Material with Oil Burn Test

The screening test performed here was not time-based, and the true burning rate was not measured. The sample burned with the intensity of an oil candle or alcohol lamp, producing laminar flames of ~1 in. (2.54 cm) in length. No violent reaction was noted; however, the oil impregnated regions were consumed in a matter of seconds indicating accelerated combustion compared to uncontaminated samples. There was some indication of yellow flames, possibly indicating some sodium in the flame; however, the spectrum was not analyzed for elements or compounds. An example of the oil-doped ignition test in a laboratory setting is shown in Figure 5.

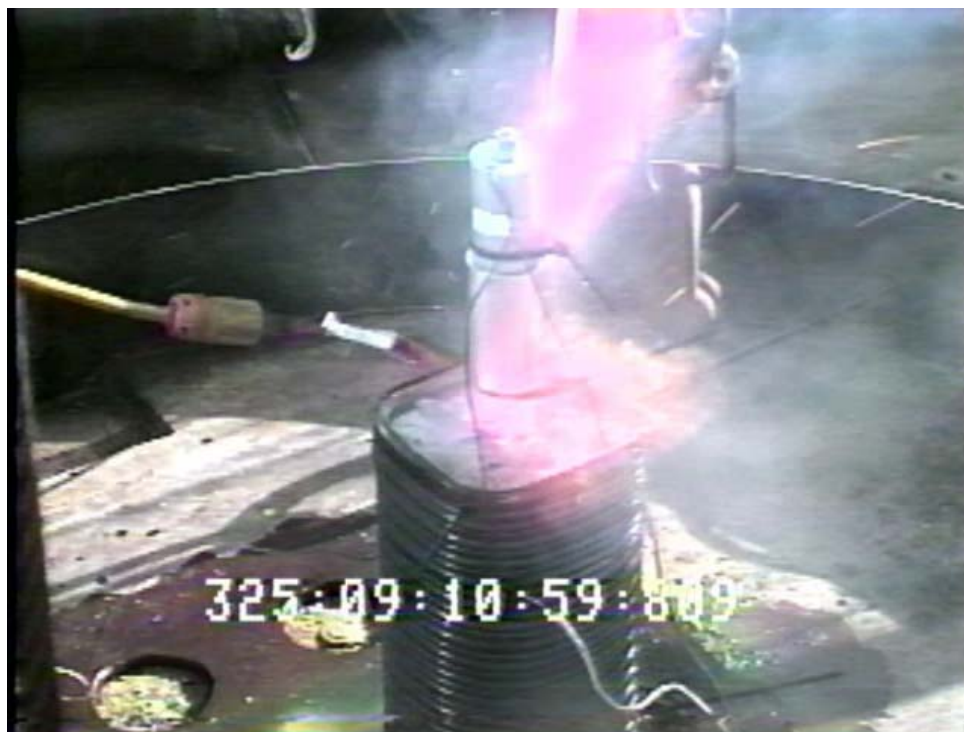
Figure 7
Flame Ejecting from Top Vent Ports

- The .410 cartridge was initiated (remotely).
- Hissing sound occurred.
- Reaction occurred inside the canister at a significantly increased rate of gas production.
- Oil from the filter was forced onto the outside of the canister and began to burn on the external surface of the canister (Figure 7).
- “Blow torch” behavior resulted in 50 percent melting of the solenoid housing (Figure 9).
- Canister did not burst, but the upper surface of the canister burned through.
- Large amounts of white vapor were formed.

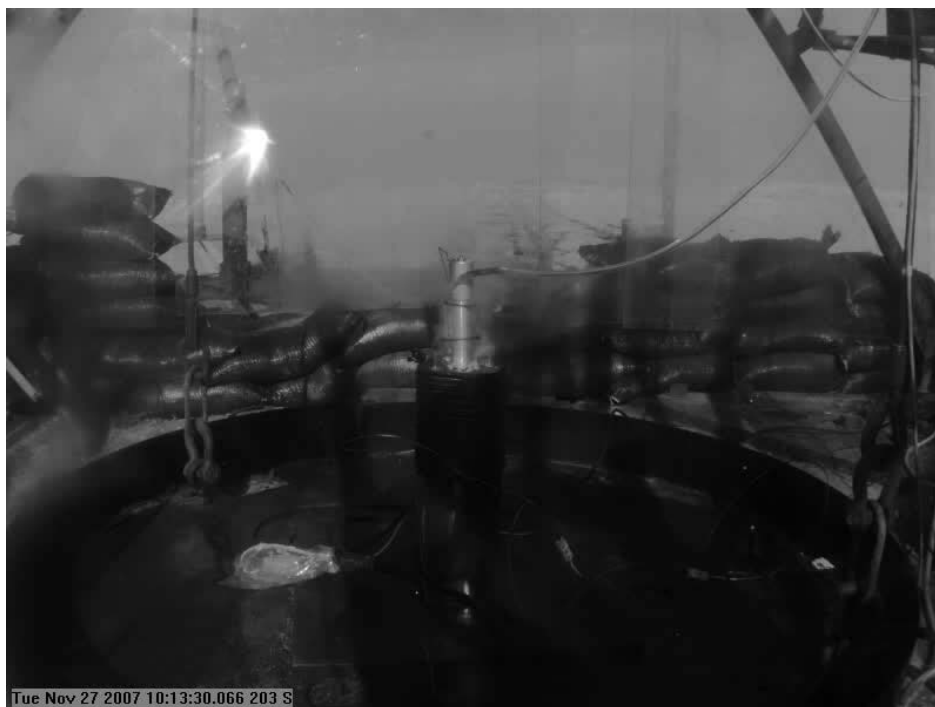
Figure 9
SCOG26 with Remote Solenoid Activator and Remote Oil Fill System

- Full scale SCOG26
- 600 mL of oil was poured onto the lid of the SCOG, where it seeped through the vent ports into the filter material, and then onto the chemical briquette (Figure 9).
- Ignition used the standard .410 igniter cartridge, remotely actuated using a solenoid driven striker.
- SCOG26 was unconfined and free-standing.
- Chemical briquette was initially unfractured.
- Top half of SCOG26 was wrapped in heating tape to maintain test article temperature above 40 °F (4.4 °C) during 4-day soak time.

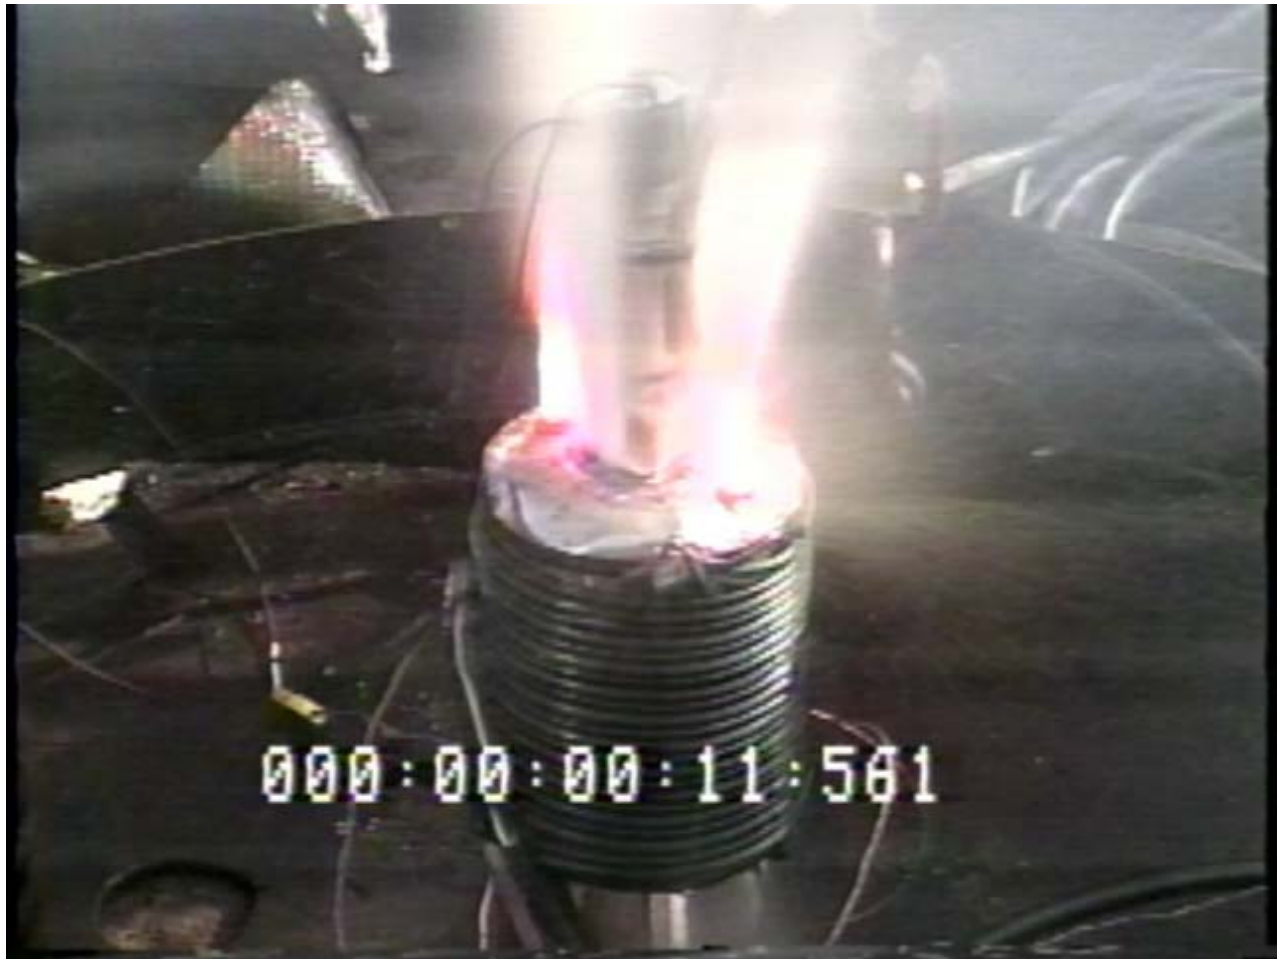
Figure 10
Flame Behavior from Primary Vent Ports, Test 3

- Some of the chlorate material continued to burn for several minutes (secondary fires of oil-contaminated pieces).
- Some of the chlorate material remained unreacted, or self-extinguished.

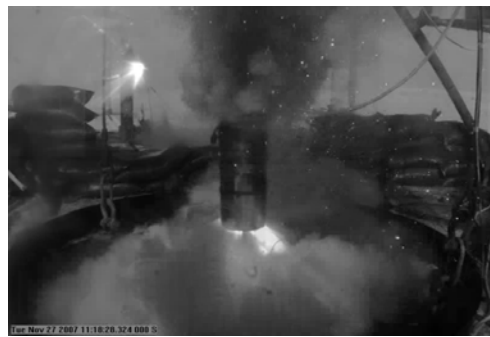
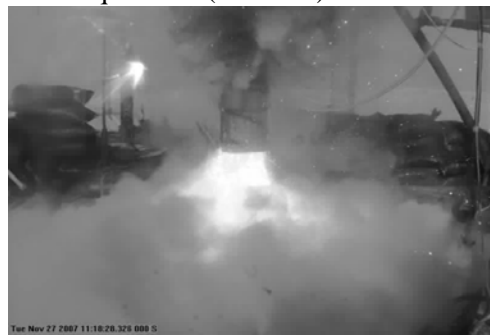
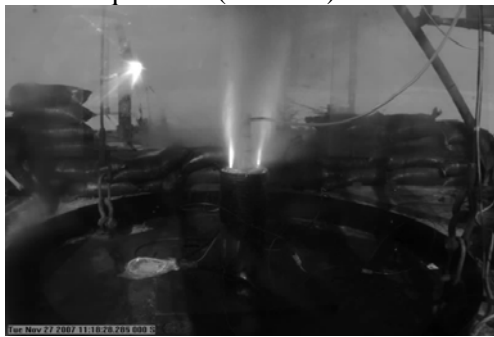
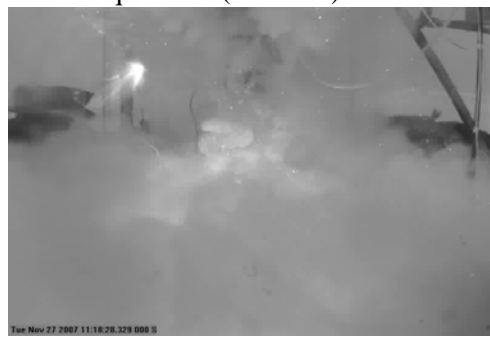
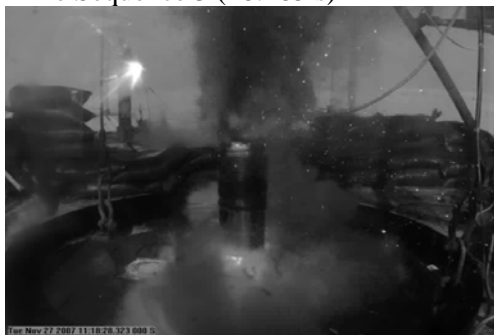
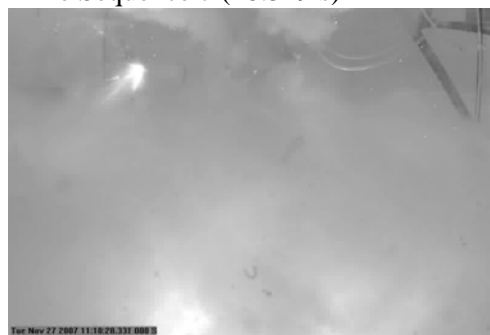
Figure 11
High Speed Video Frame Sequence Frames 1 through 8 (Test 3)

Time Sequence 1 (28:001 s)

Time Sequence 2 (28:273 s)

Time Sequence 6 (28:326 s)

Time Sequence 3 (28:285 s)

Time Sequence 7 (28:329 s)

Time Sequence 4 (28:323 s)

- It is unknown whether the test resulted in fast deflagration or detonation of VCE seen at 14 to 25 ms after initial breach.
- The entire sequence of events from canister breach to vapor cloud explosion and subsequent camera sensor overload occurred in about 25 ms.
- Canister broke into three primary fragments: one small fragment ripped off the base; the rest of the base remained intact; and the lid, filter plate and walls of the canister remained integrated despite partial failure of some seams and marked deformation (Figure 14).
- The solenoid assembly remained attached to the filter assembly and was pushed into the canister body by the force of impact into the weight.
- The canister impact on the overhanging weight had no effect on the test or secondary events.

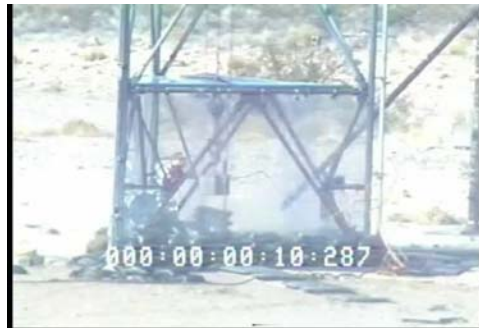
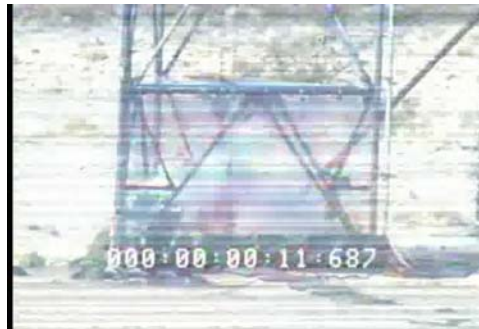
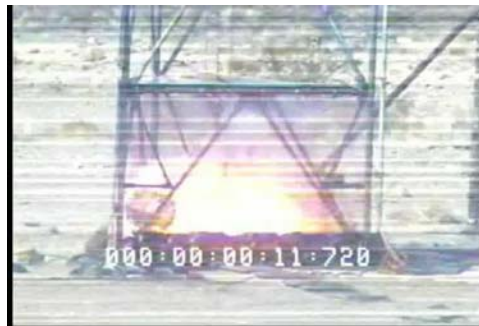
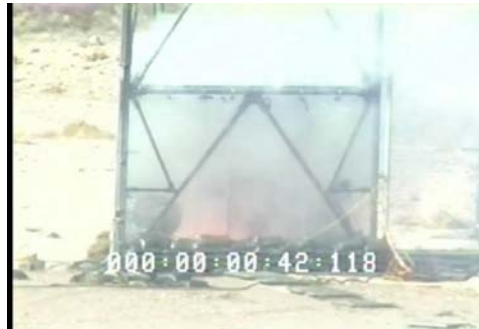
Figure 13
Test 3: Selected Long Range Camera Views

Time Stamp: 10:287 s

Time Stamp: 11:687 s

Time Stamp: 11:720 s

Time Stamp 42:118 s

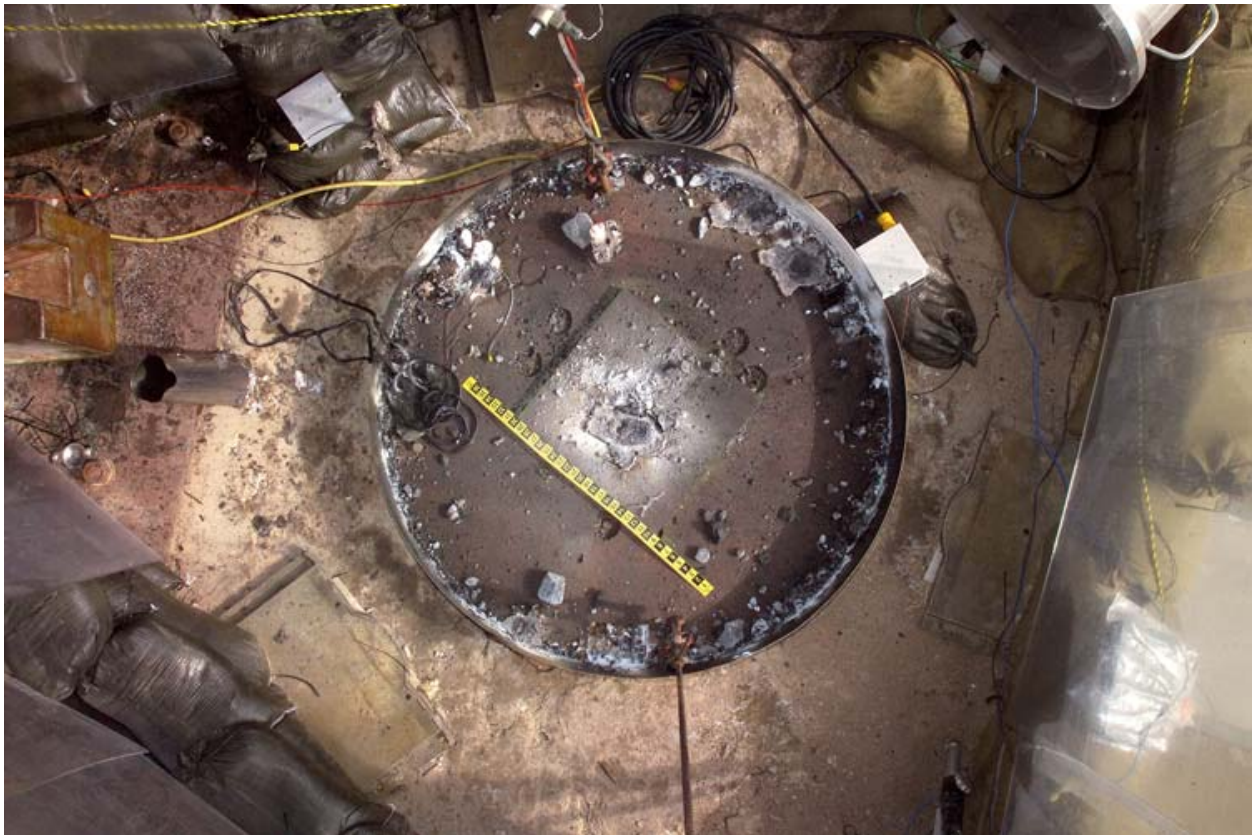
Figure 14

Test 3: Overhead View of Ground Zero Debris

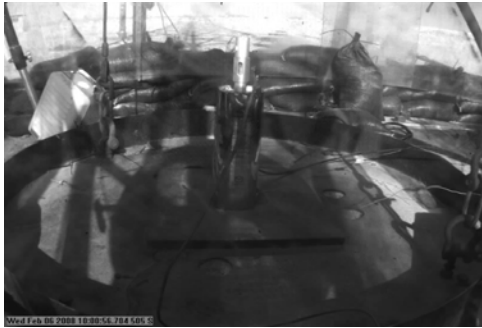
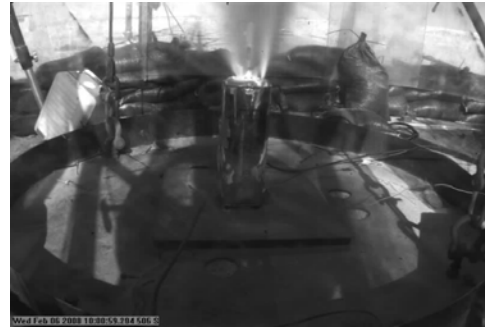
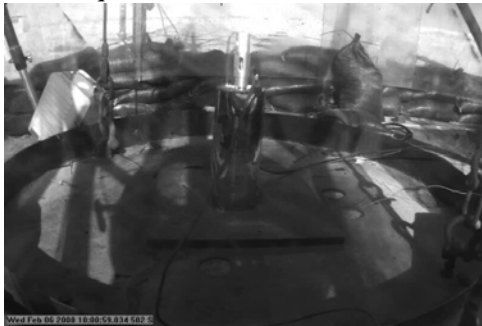
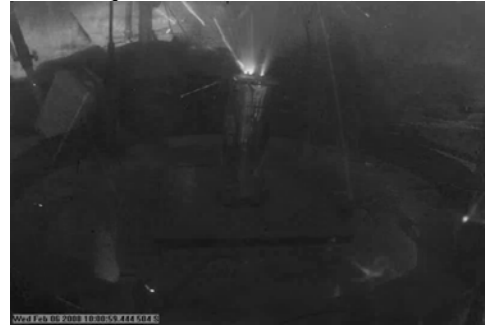
Figure 16

- Flames began coming out the vent ports and relief valves ($t = 2.52$ s) (Time Sequence 2, 3) (Figure 16).
- Canister continued to bulge and flame jets continued to grow vertically from top ports (Time Sequence 4, 5).

Initial Reaction through Primary Pressure Relief Ports and Vent Holes

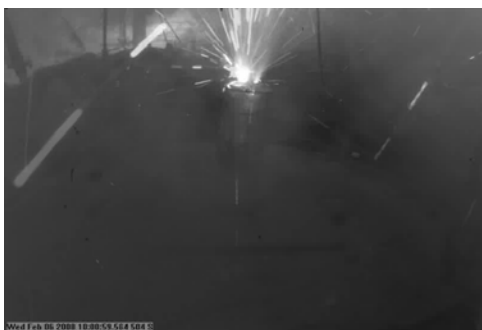
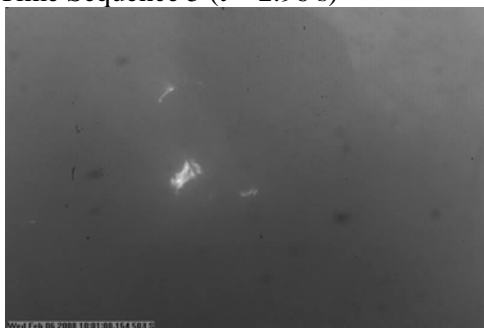
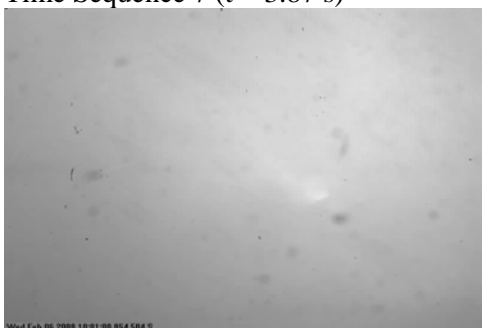
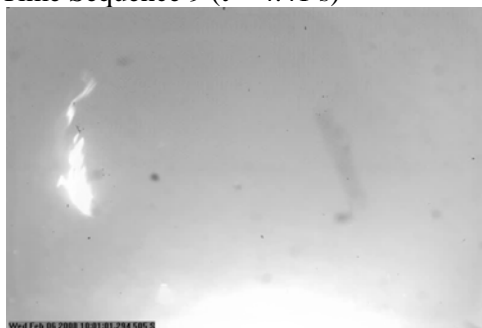
Figure 17

- The canister was momentarily stationary ($t = 3.83$ s) on its side before accelerating along the ground of the test cell to the edge of the lower containment ring ($t = 3.85 - 4.16$ s) with an average speed of 8 ft/s or less (Time Sequence 7) (Figure 17).

- The port jet flame region appeared to become nearly stationary at $t = 4.16$ s, indicating the canister had come to a halt at the edge of the containment ring (Time Sequence 8) (Figure 17).

- Another bright expanding region formed and again overwhelmed the camera sensors ($t = 4.83$ to 4.89 s) (Time Sequence 10-12) (Figure 17).
- Light levels once again subsided, allowing camera sensor recovery, and the remaining material smoked/burned for the duration of event (Time Sequence 13, 14) (Figure 18).

Canister “Tip-over,” Movement across Enclosure, and VCE Events

- The lack of any restraint on the candle allowed the bulging of the canister bottom to create an unstable shape and cause a tip-over.
- Damage and denting to the lower containment ring and housing on a camera tripod indicate the solenoid obtained significant velocity, believed to be during the primary energetic release event (Time Sequence 8, t = 4.17 s).

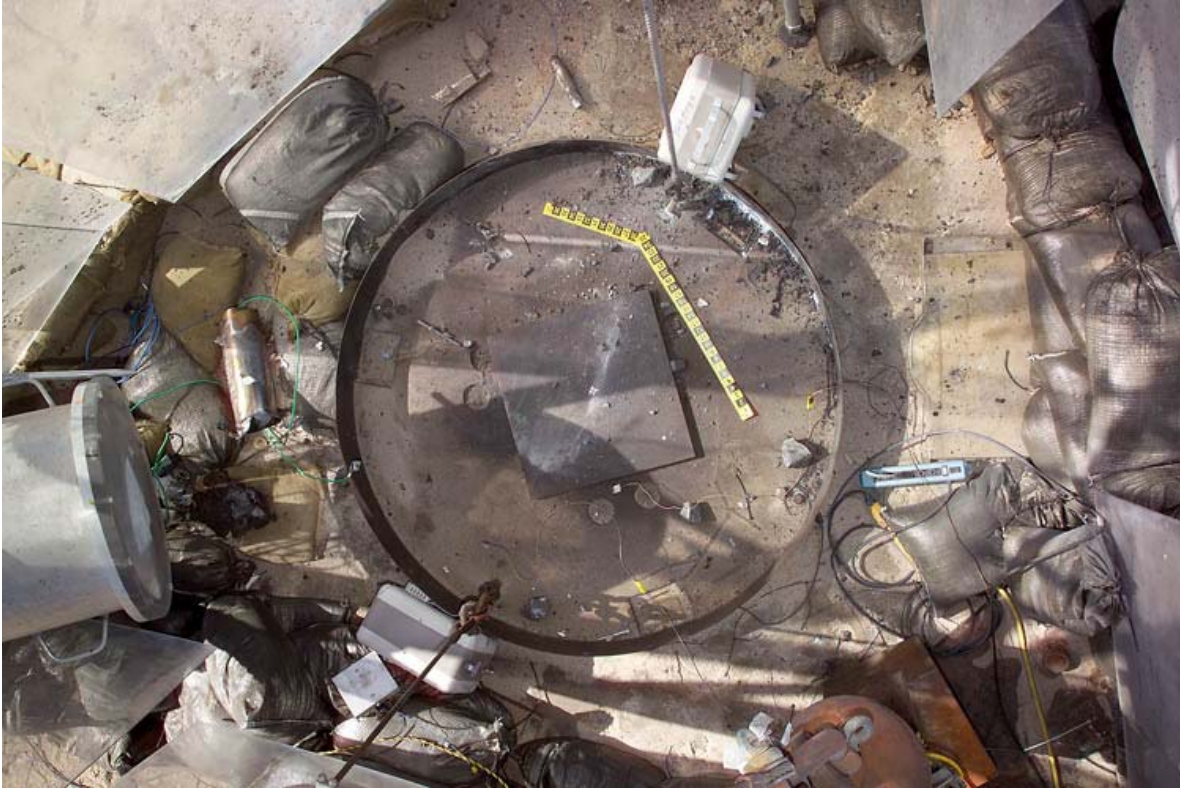
Figure 19
Top Down View of Test 4 Aftermath

- Canister showed no signs of side wall breach.
- Coloration of the canister steel exterior indicated that the external temperature reached 900 to 1000 °F (480 to 540 °C) during the event.

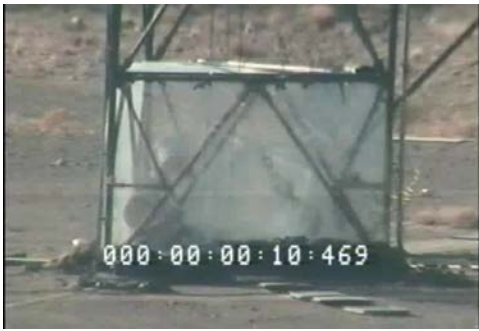
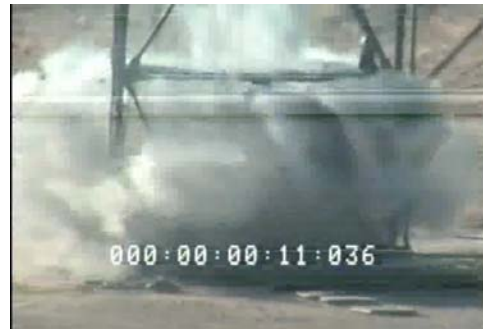
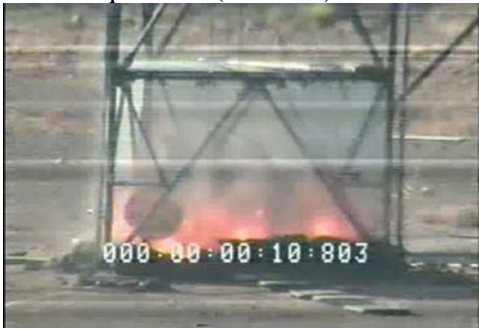
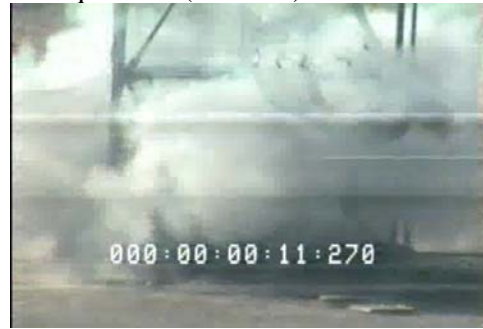
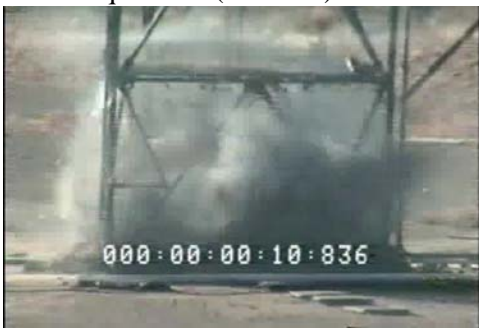
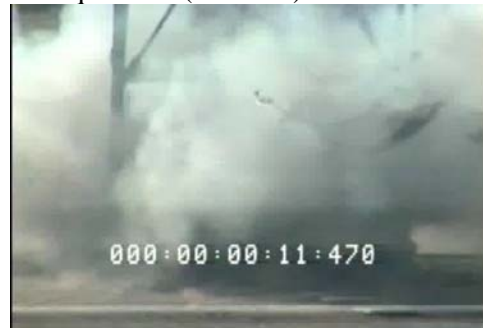
Figure 21

- The .410 cartridge was initiated (remotely) ($t = 0.0$ s)
- Hissing sound occurred
- White vapor began to flow out of primary vent ports (Time Sequence 1) (Figure 21)
- Pressure relief devices activated at ~ 0.6 - 0.70 s after initiation
- Canister bulging was noted into the openings of the holder just prior to burst
- Burst occurred 0.72 s after initiation (about 3 times faster than previous test COGA4 value of 2.2 s)
- Formation of fireball was seen immediately following initial burst (Time Sequence 2) (Figure 21)
- Lexan containment screens were blown off the test tower (Time Sequence 3-8) (Figures 21 and 22)
- Fragments were impacted into the Lexan containment screens
- Fragments were blown up to 120 ft from the test tower
- Some chlorate material on the test cell floor continued to burn for several minutes and some unreacted chlorate material on the test cell floor never ignited

Test 5: Selected Long Range Camera Views of Primary Events

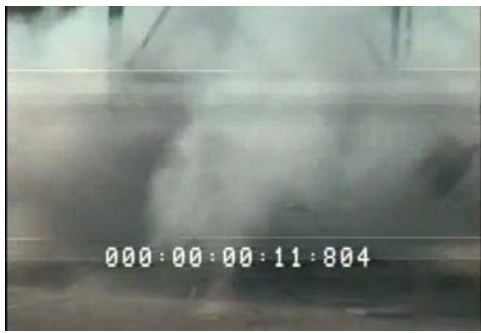
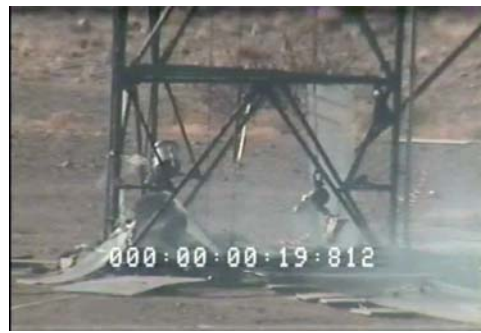
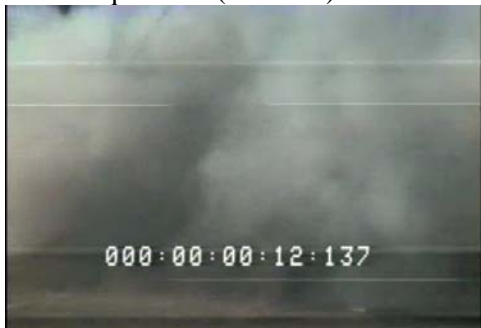
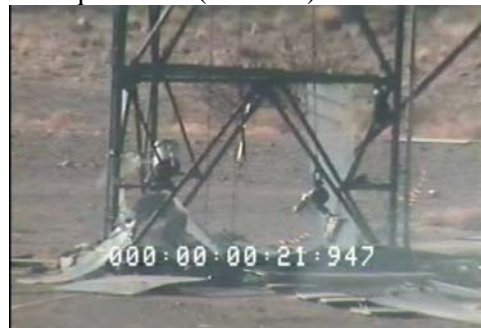
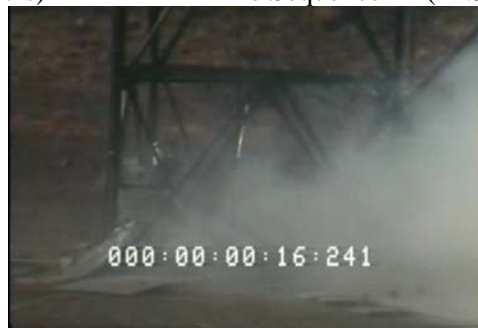
Figure 22

Time Sequence 7 (11:804 s)

Time Sequence 10 (19:812 s)

Time Sequence 8 (12:137 s)

Time Sequence 11 (21:947 s)

Time Sequence 9 (16:241 s)

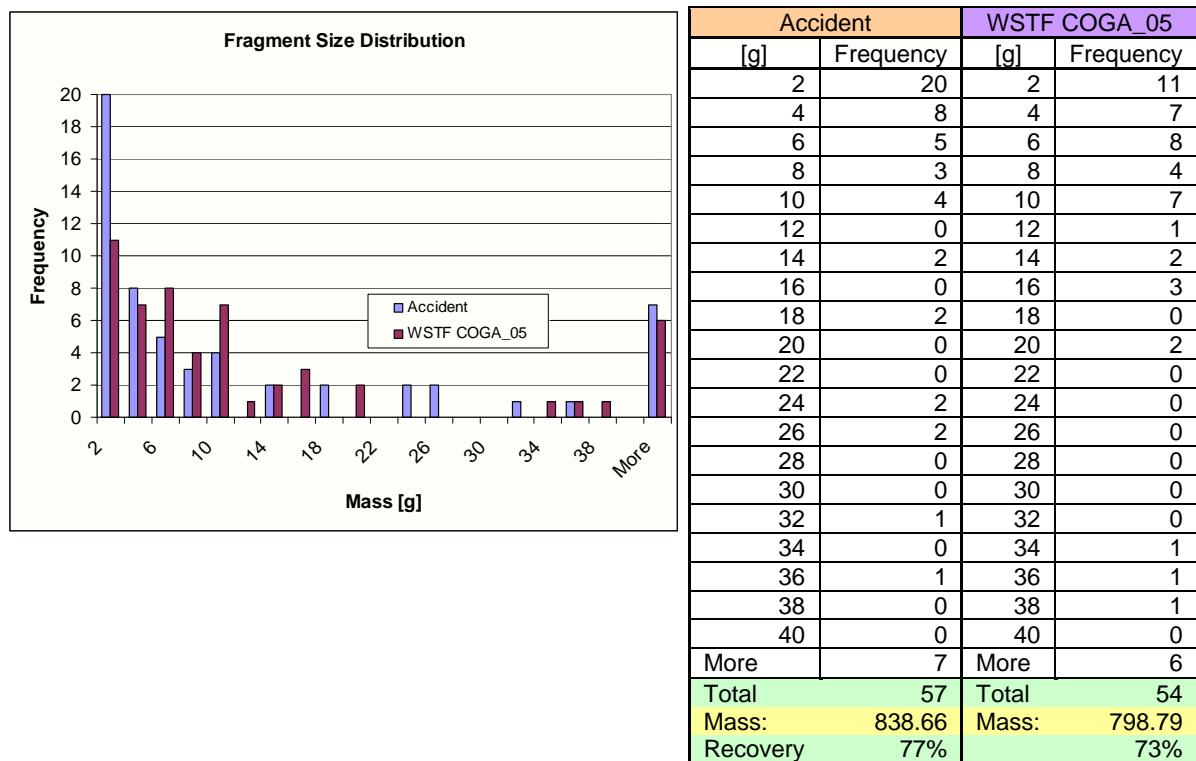
Figure 23
Histogram and Size Distribution Table

The size and distribution of recovered pieces allowed the creation of a histogram for direct comparison of the two events (Figure 23).

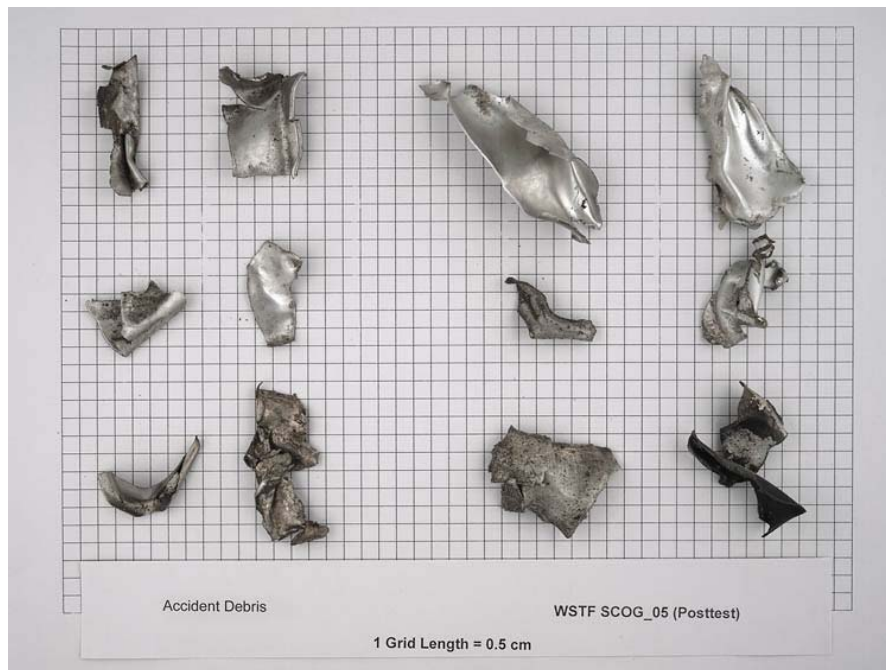
Figure 24

The following photos (Figures 24 through 27) are a direct comparison of the Test 5 fragments and fragments recovered from the scene of the original accident.

Test 5: Side-by-Side Comparison to Accident Fragments Set A

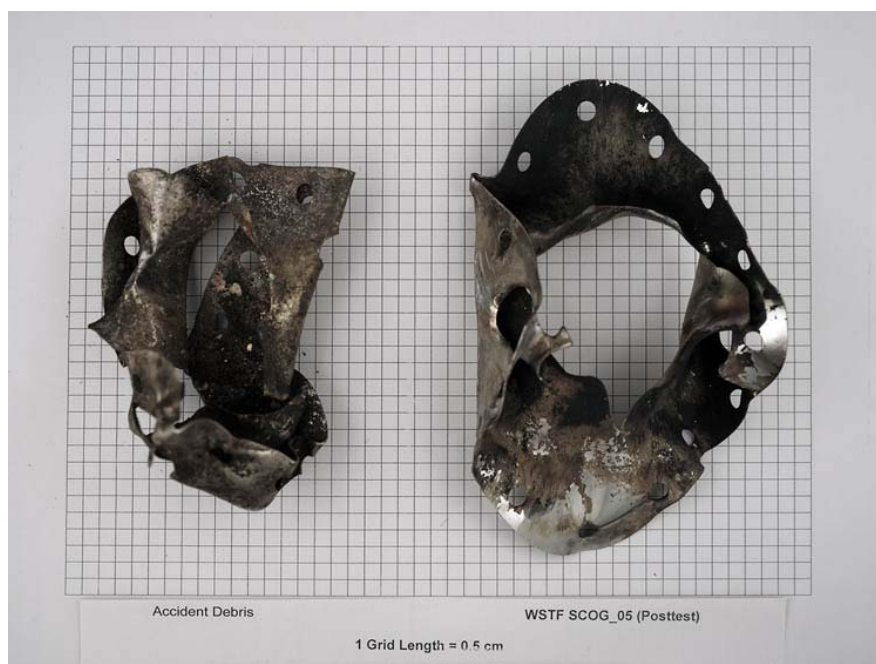
Figure 25

Test 5: Side-by-Side Comparison to Accident Fragments Set B

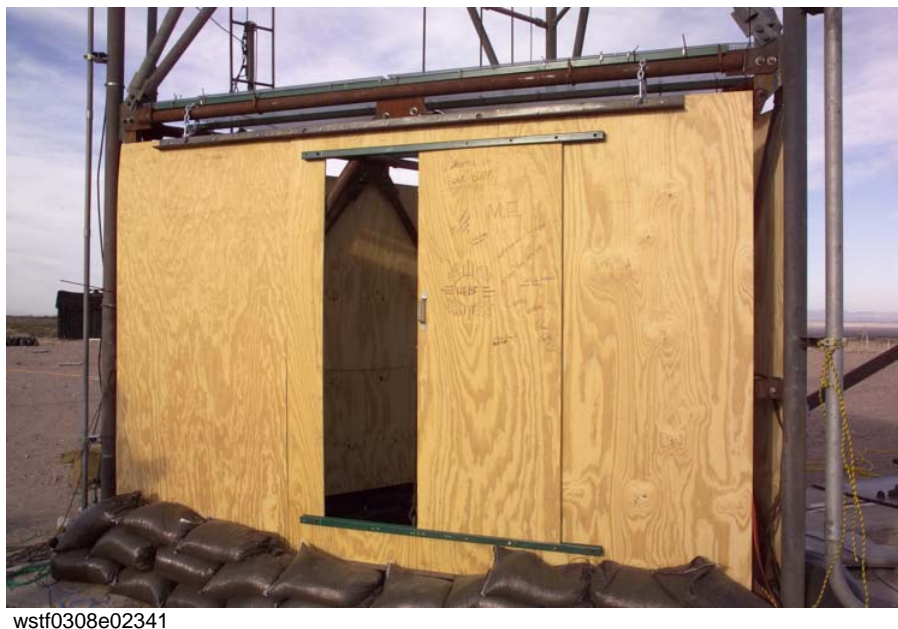
Figure 28
Plywood Enclosure and Witness Plate at Ground Zero Tests 6 through 12

The near complete destruction of the Lexan enclosure required building a new enclosure and witness plate system. The option to use 0.5-in.-thick plywood hanging walls was chosen, and the result is shown in Figure 28.

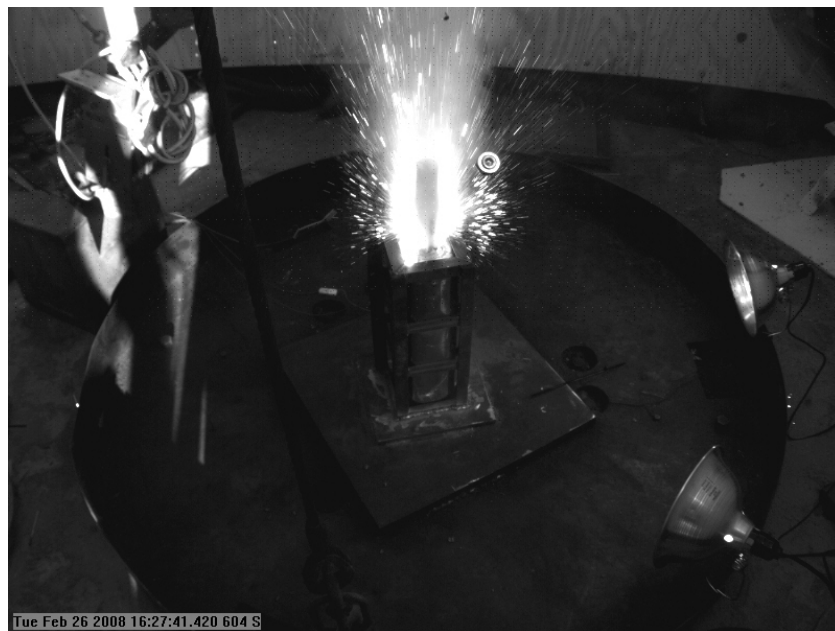
Figure 29

- The .410 cartridge was initiated (remotely).
- Hissing sound occurred.
- Canister bulged.
- Pressure relief devices both activated near $t = 2.08$ s.
- Flames jets 2 to 4 in. in length formed at relief valves ($t = 3.00$ s), along with white vapor.
- Canister continued to bulge and spit flame from the relief valves.
- Relief valve fittings ejected from both sides of container nearly simultaneously, allowing a larger vent path to form ($t = 3.98$ s).
- Canister did not burst; however, flame sizes increased in spurts to lengths of 1 to 2 ft ($t = 3.98 \sim 5.00$ s) (Figures 29 and 30).
- Flames diminished to 1 to 2 in. again ($t = 5.2+$ s) as canister bulging decreased over same time span.
- SCOG continued to decompose nominally until remaining briquette was consumed.

Flame and Vapor at $t = 4.182$ s

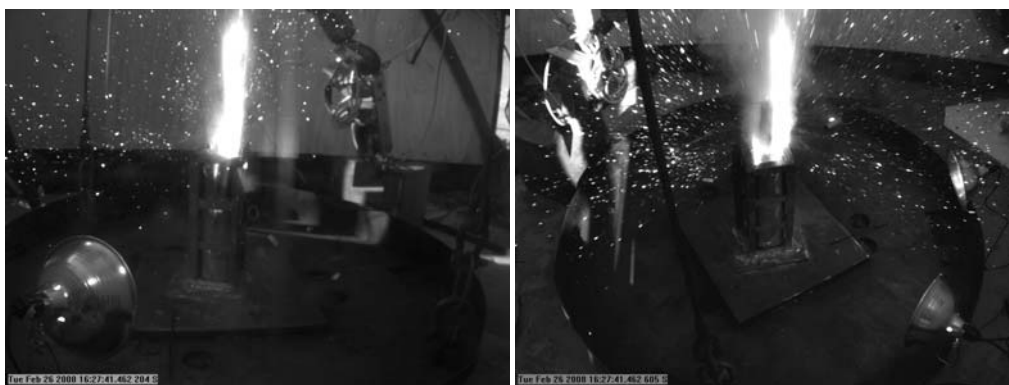
Figure 30
COGA6 Flames at $t = 4.296$ s (2 Views)

(Note: Pressure relief device top piece in flight towards camera position at right center of flame plume)

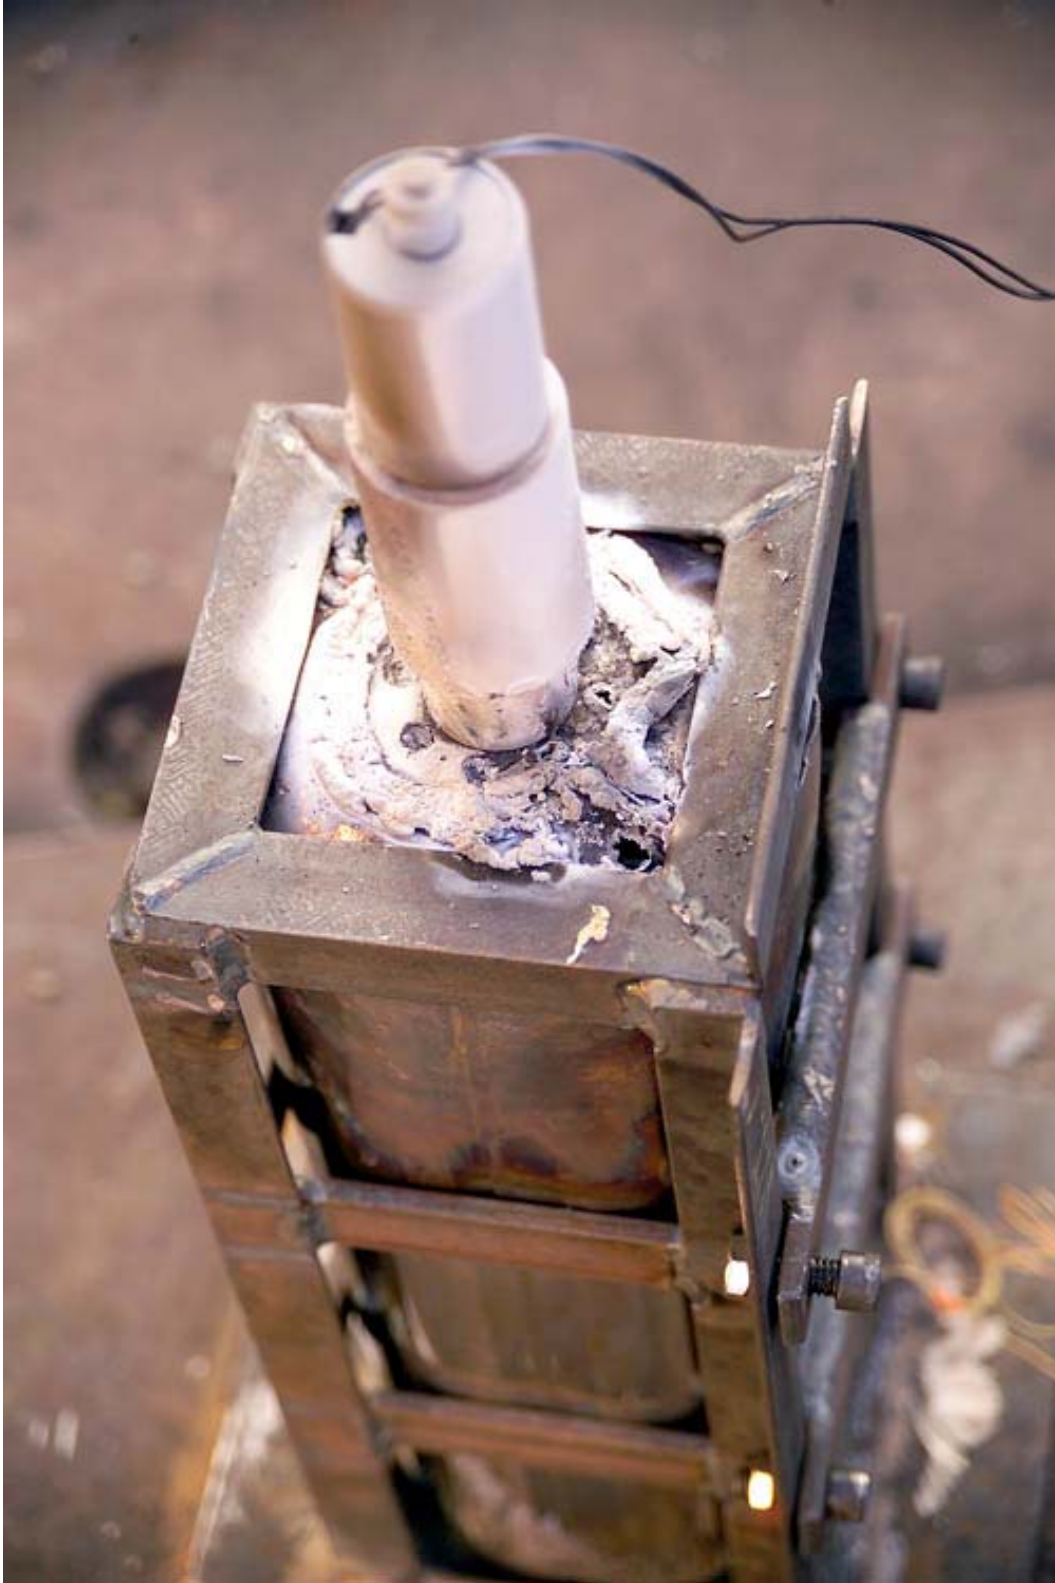
Figure 31
COGA6 Posttest View

- The reaction of COGA6 was energetic, and a burst event was deemed highly probable had the pressure relief devices not functioned.
- The end result was behavior more like a solid rocket motor for the primary energetic material phase combustion event prior to reverting to a more normal decomposition phase for the remainder of the test.

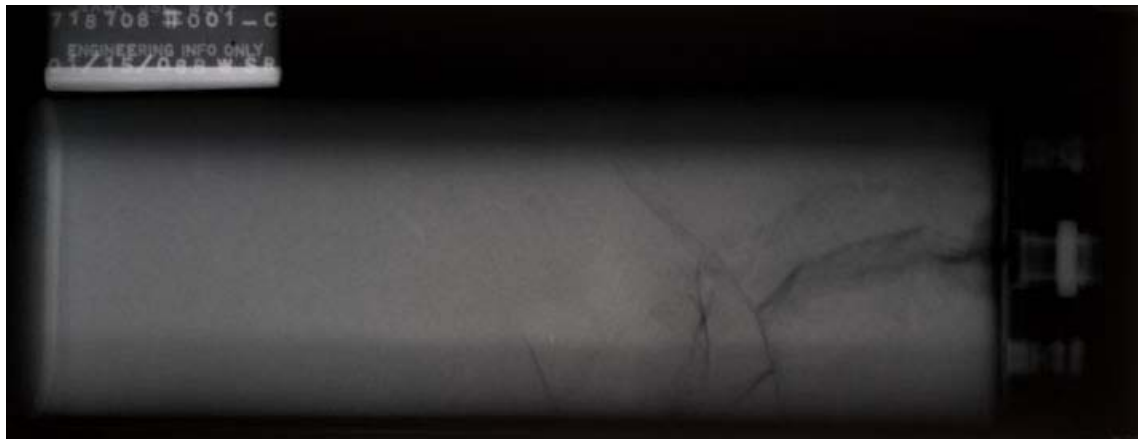
Figure 32
Radiograph of COGA7 Test Article Primary Crack Zone (SN/001)

- Full scale SCOG26
- 25 mL of oil was poured directly into the chemical briquette through the ignition port.
- Ignition used the standard .410 igniter cartridge, remotely actuated using a solenoid driven striker.
- SCOG26 was constrained by a holder similar to the SCOG26 holder involved in the accident.
- Chemical briquette was initially fractured (Figure 32).

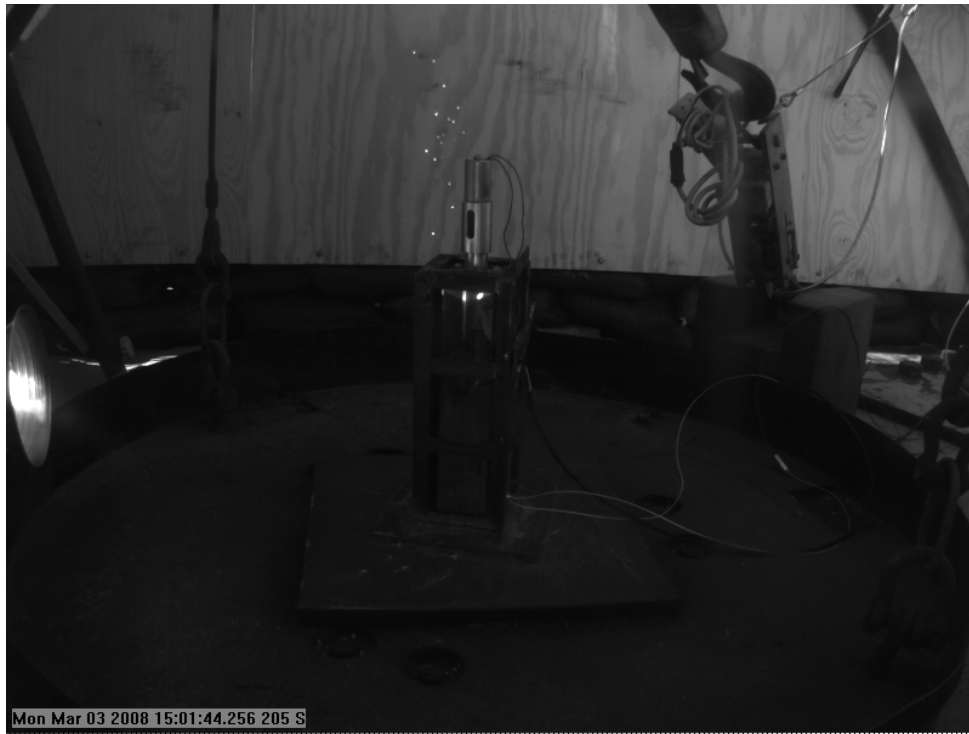
Figure 33

- The .410 cartridge was initiated (remotely).
- Hissing sound occurred.
- Canister bulged.
- One of two pressure relief devices activated, and some particulate was seen exiting the port (Figure 33).
- No major breach or vapor was formed.
- The SCOG26 continued to produce oxygen in the same manner and time frame as an uncontaminated SCOG26.

Minor Ejection of Some Hot Particulate Material during Test through Left Pressure Relief Port

- The SCOG26 exhibited some of the characteristics of fuel contamination behavior, but to a lesser degree than previous tests.
- Gas production increased beyond nominal operation and some bulging of the canister was evident.
- Thermal output in the region of oil addition indicated a localized heating of the external surface sufficient to allow oxidization of the surface, as indicated by blue to straw-colored discoloration near the top of the canister (Figure 34).
- Some extrusion of top filter material through primary vent ports was observed, but no escaping Hopcalite material was evident (Figure 35).
- 25 mL of oil appeared to enhance the off-nominal behavior; however, the amount was insufficient to drive the system to failure or produce a hazardous event.

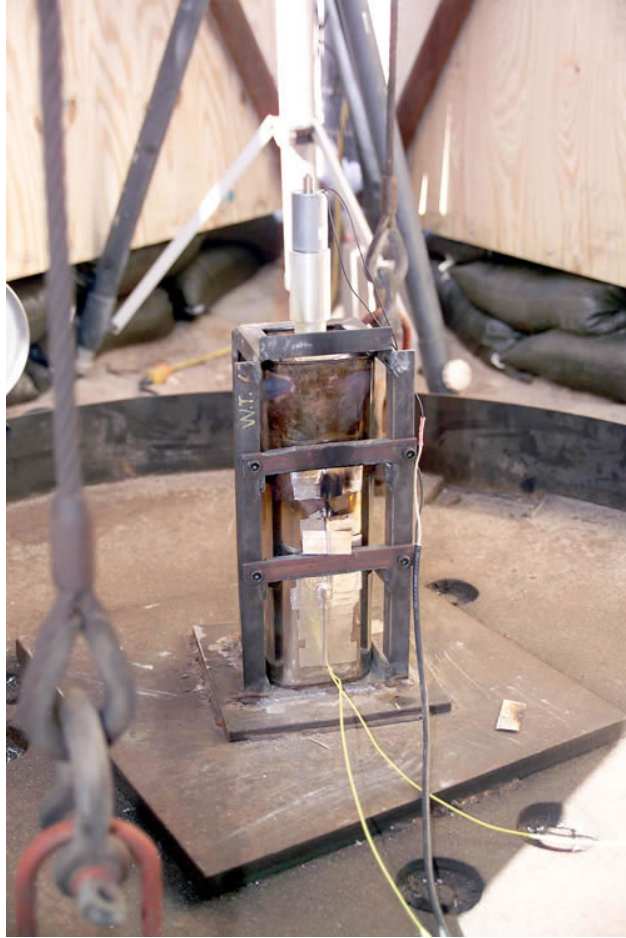
Figure 34

Posttest SCOG26 in Holder with Thermal Discoloration (Test 7)

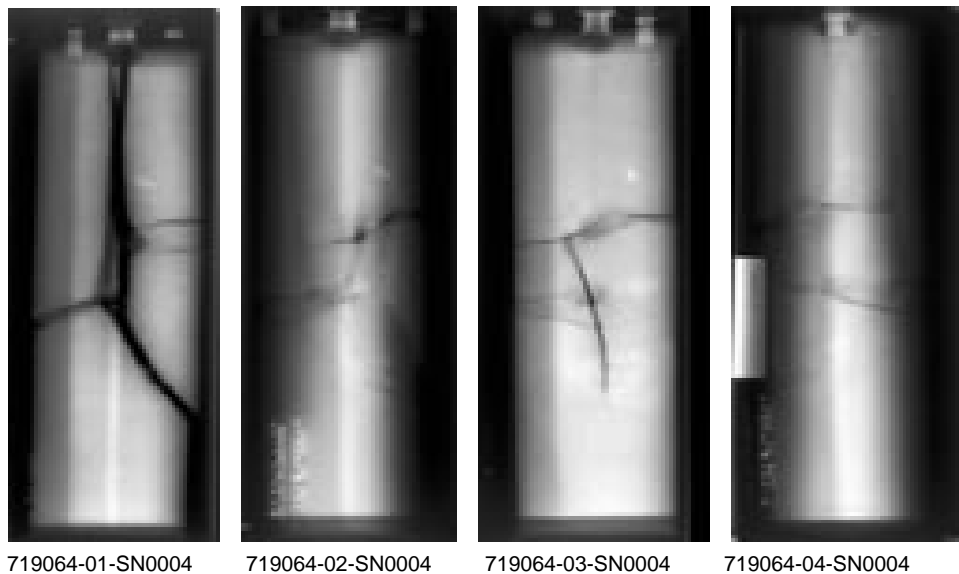
Figure 36
Radiographs of COGA8 Test Article Primary Crack Zone (SN/004)

- Full scale SCOG26
- 100 mL of oil was poured directly into the chemical briquette through the ignition port.
- Ignition used the standard .410 igniter cartridge, remotely actuated using a solenoid driven striker.
- SCOG26 was constrained by a holder similar to the SCOG26 holder involved in the accident.
- Chemical briquette was initially fractured (Figure 36).

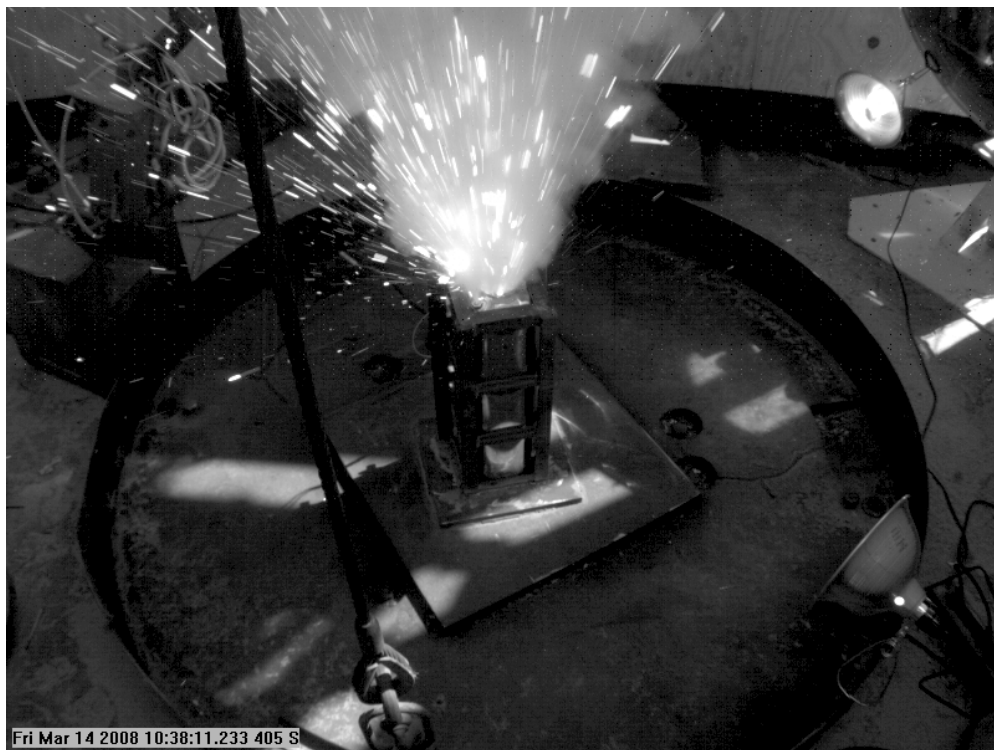
Figure 37

Pyrotechnic Behavior through Vent Ports and Canister Bulging into Holder (Test 8)
